Rail Accident Investigation Branch

# Rail Accident Report

## **Derailed at Grayrigg 23 February 2007**

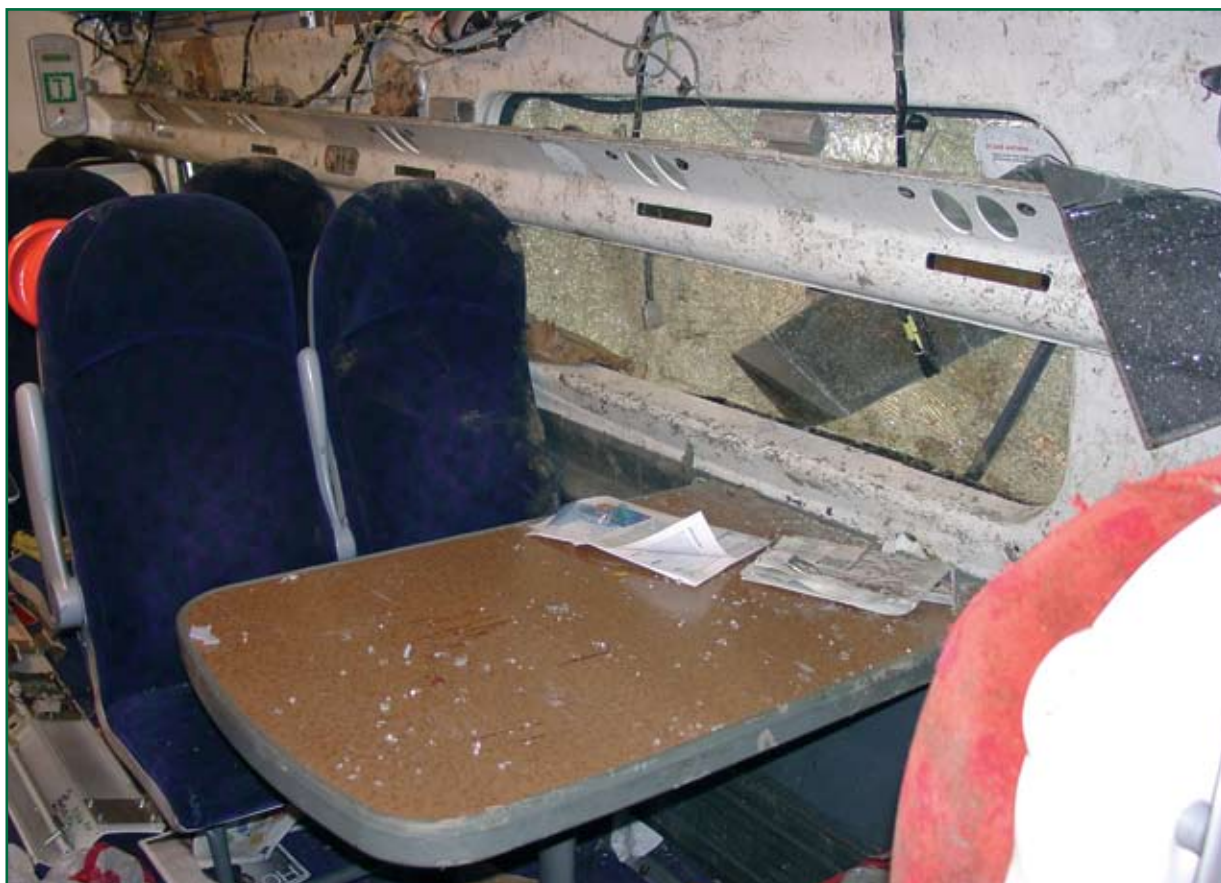
553 The interior of the passenger compartment in vehicle one remained largely intact except for the detachment of all six reading light panels from their mountings. The retaining locks, which secure the outboard edges of the panels to the interior of the bodyside, had distorted and allowed the panels to swing down on hinges mounted on the luggage racks. Five panels detached completely (Figure 39); the sixth remained attached by its hinges.

Figure 39: Detached reading light panels in the leading right-hand side of vehicle one

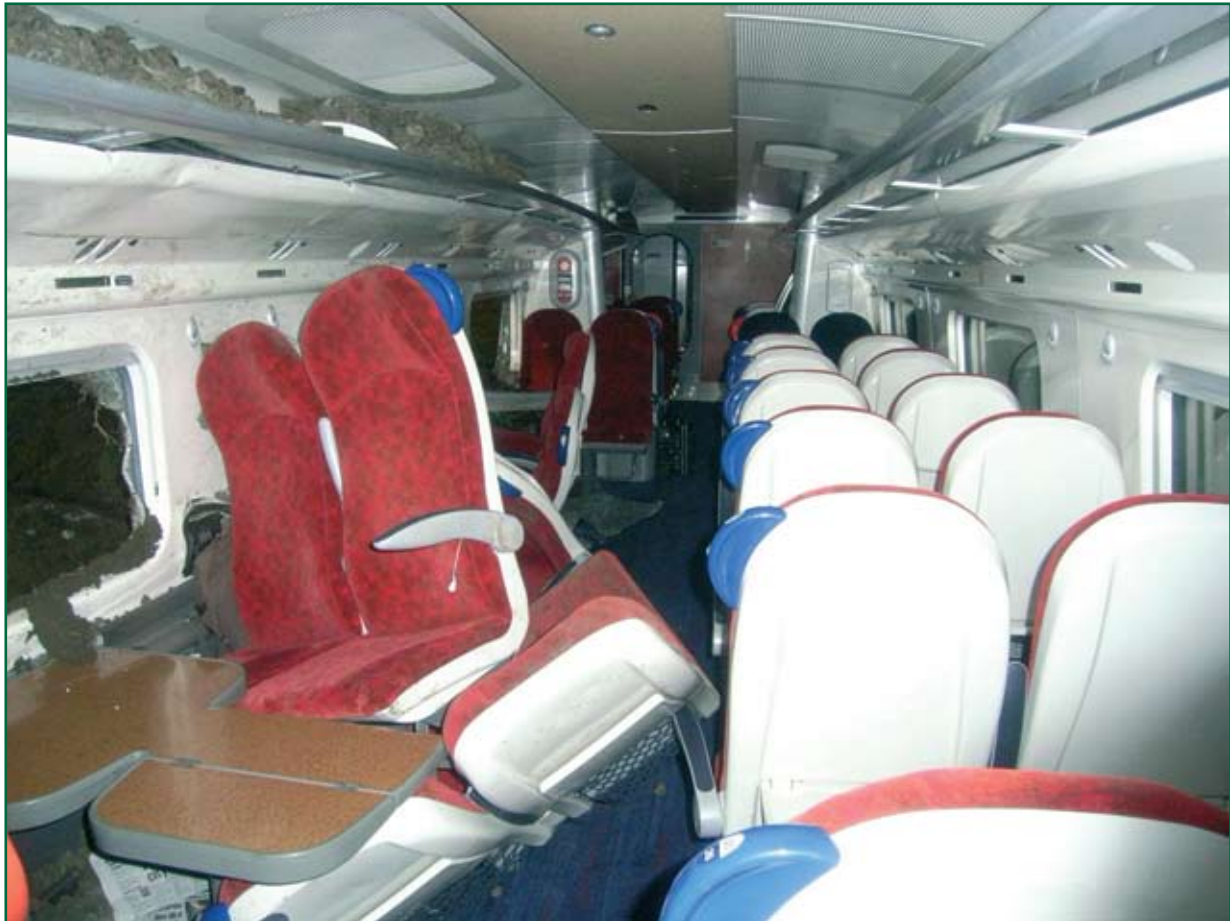
Figure 40: Detached seating on the left-hand side of vehicle two

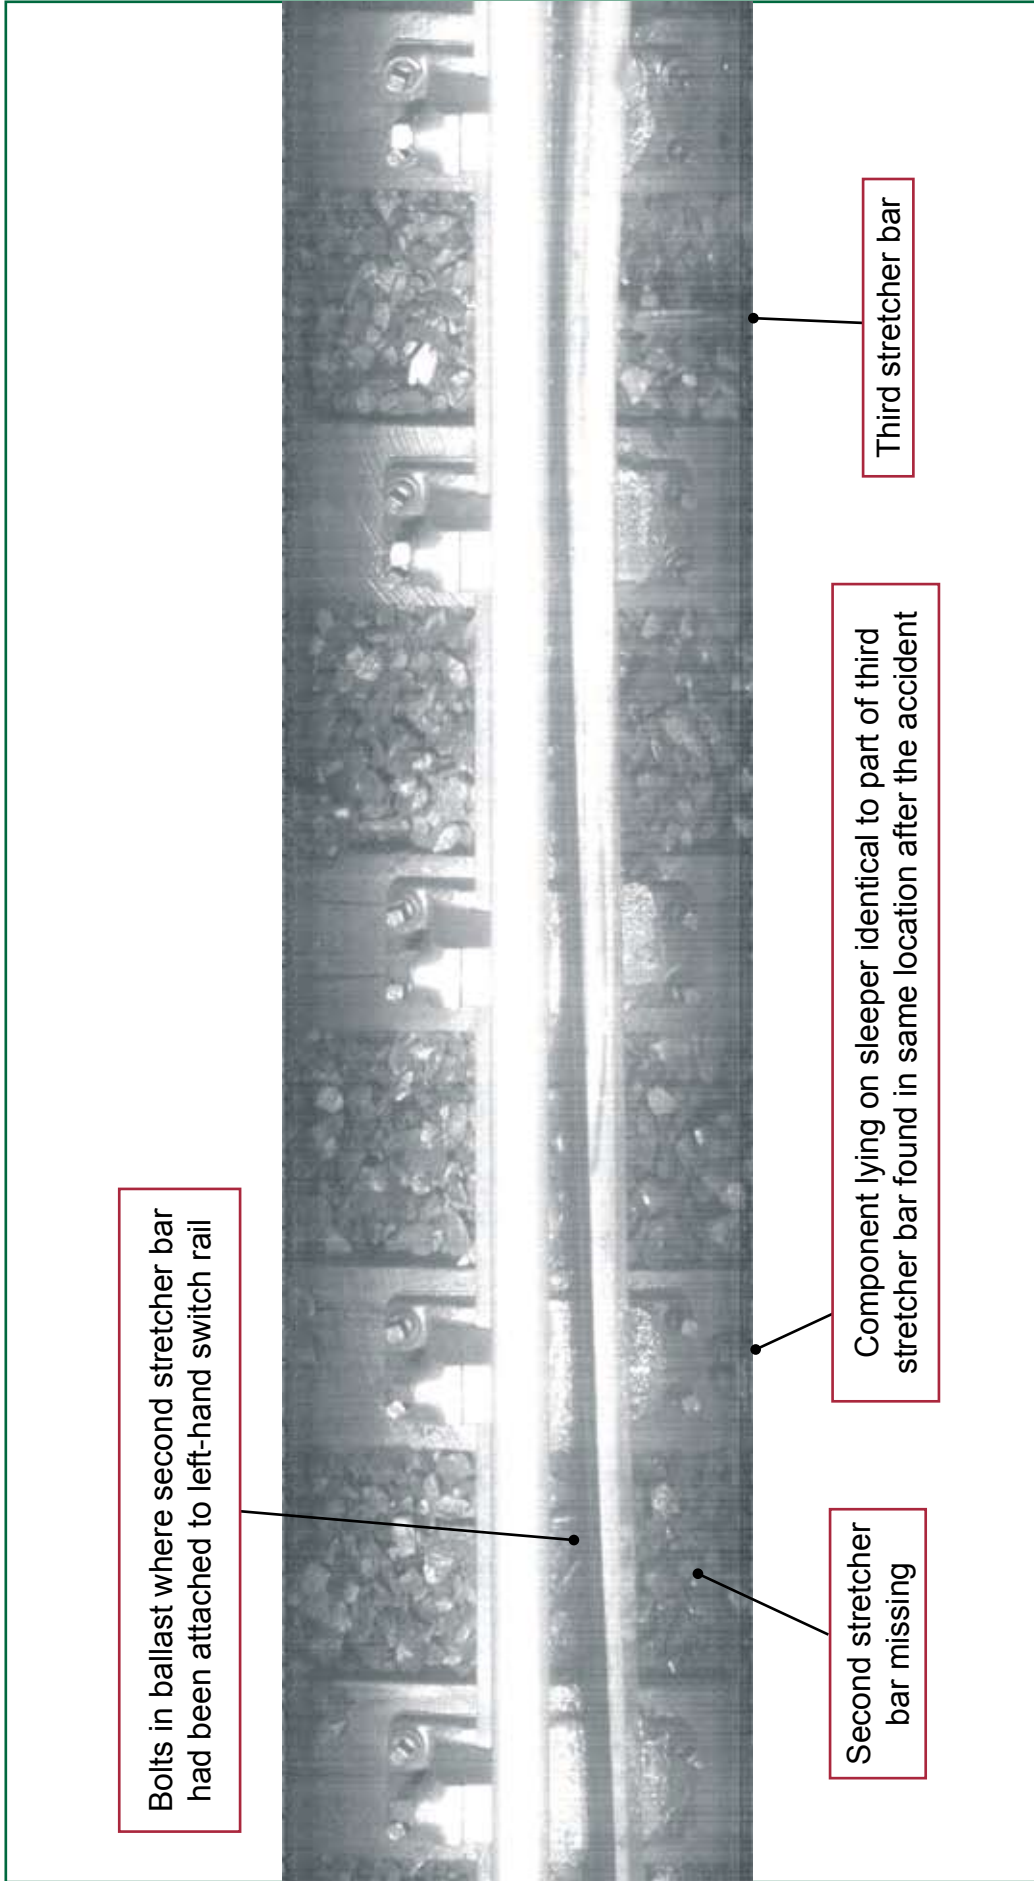
Bolts in ballast where second stretcher bar had been attached to left-hand switch rail
